#### Flood Control Project Maintenance Levee Inspections

## 2008 Channel Summary Report

# **Placer County**

Channel
Truckee River

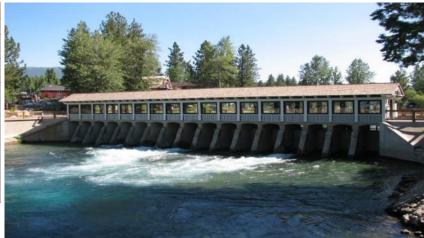
Report Line	1
Location	
Category	Structures & Concrete Lined Channels
Item	Electric Gate Operators

Outlet gate structure upstream from hwy 89 center of struture GPS 39.16716 -120.14392

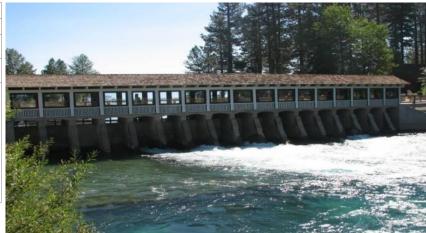
Report Line	1
Location	
Category	Structures & Concrete Lined Channels
Item	Electric Gate Operators

Outlet structure

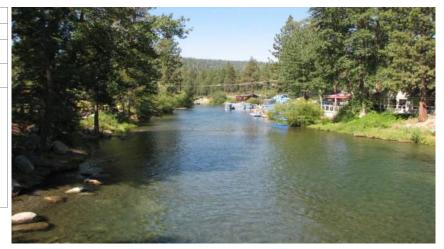
Report Line	3
Location	
	Rivers, Channels & Designated Floodways
Item	Vegetation & Obstructions

Downstream from hwy 89 bridge

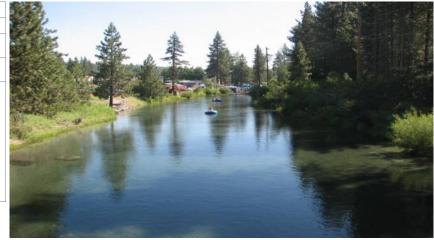
Report Line	3
Location	
Category	Rivers, Channels & Designated Floodways
Item	Vegetation & Obstructions

Upstream from bike bridge

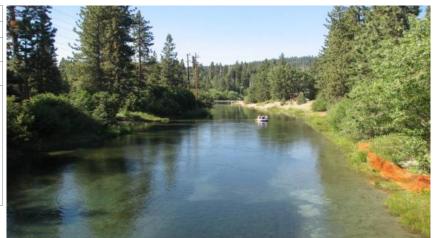
Report Line	3
Location	
Category	Rivers, Channels & Designated Floodways
Item	Vegetation & Obstructions

Downstream from bike bridge

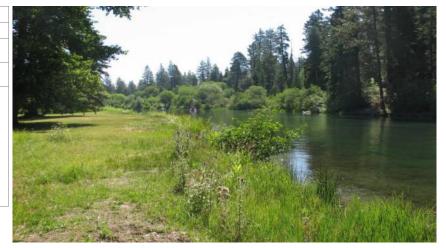
Report Line	3
Location	
Category	Rivers, Channels & Designated Floodways
Item	Vegetation & Obstructions

Upstream from Tahoe City Lumber Yard

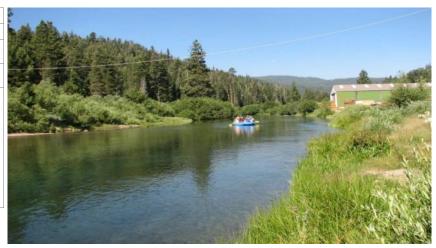
Report Line	3
Location	
Category	Rivers, Channels & Designated Floodways
Item	Vegetation & Obstructions

Downstream from Tahoe City Lumber Yard near downstream limit GPS east end of yard 39.16248 -120.15190
